# Building Socio-Ecological Resilience in Inle Lake: Post-Disaster Environmental Assessment and Rehabilitation Plan following twin disasters

**E Guard Environmental Services, Myanmar**

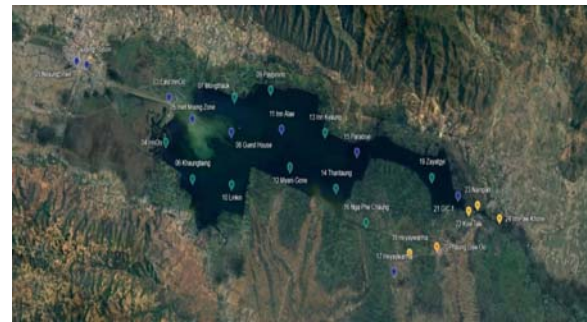
Figure 2. Water Quality Monitoring Locations

The water quality assessment indicates that pH values remained within the national surface water quality standards, while dissolved oxygen levels were generally close to the minimum threshold for aquatic ecosystems. Low turbidity and TSS values suggest

relatively good water clarity at the sampled locations. However, the presence of ammonium and elevated oil and grease concentrations at selected stations highlights the need for continued monitoring and pollution control measures to maintain ecological integrity.

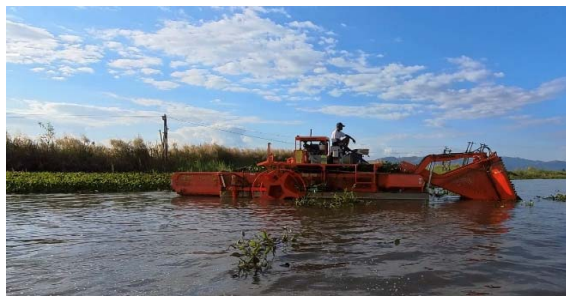
Figure 3. Rehabilitation Activities Conducted Following the 2024 Flood and 2025 Earthquake (Hyacinth Removal and Dredging Activities)

Rehabilitation activities implemented following the flood and earthquake included water hyacinth removal, dredging of sediment-affected waterways, and restoration of navigation channels. These interventions contributed to improving water circulation, reducing environmental pressures, and supporting local livelihoods dependent on fisheries, transportation, and tourism (MEAA, 2025).
